# FAILURE OF STEEL STRUCTURES: RETHINKING SOME OF THE AFTERMATHS

**Anthimos ANASTASIADIS**

**Abstract.** Steel structures are the most ductile systems; however they are prone to instability phenomena due to their inherent slenderness. Looking at the real events of over 50 years, it was observed that steel structures, when they are subjected to seismic actions, respond, relatively, in an acceptable way, avoiding a global collapse. In case of quasi-static loads, such as snow, overloading, due to earth infill in case of green roofs, or indirect actions, coming from geometrical imperfections or lack of bracing, fail under a sudden way. A failure should be approached by any type of combination of cumulated errors in design, construction, operation and maintenance. The paper is focused on failures, in quasi-static loads, of the first stage in the design and construction phase of a project. It attempts through a technical classification and presentation of case studies to unveil relevant causes of collapses. From the engineering point of view, the lack of redundancy, robustness and ductility are the main factors of structural collapse. Indeed, the human nature represents the central cor

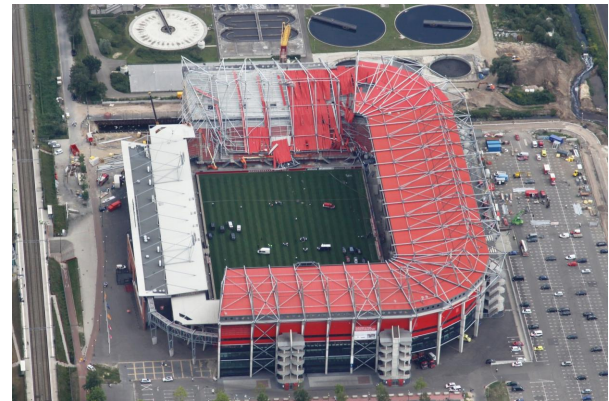
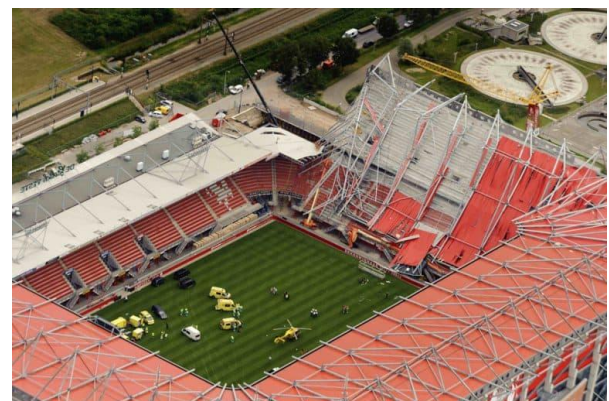
A year later, a commission was set up to investigate the incident, and it was concluded that the failure was due to technical as well as human factors (Onderzoeksraad Voor Veiligheid/Dutch Safety Board, 2012). In general, the failure is obviously due to insufficient support of the roof part and in particular to the following technical factors:

- The temporary support measures, which consisted of metal cables, and ensured the stability of the system during construction / erection, were detached before the installation of the permanent support system and the stiffening of the whole structure.
- Prior to the completion of the construction, the contractor allowed to set up, locally, in the subdivision of the structural system which collapsed, the installation of a video wall, a suspension service deck and a roof cladding section. The aforementioned introduced an additional load which would have to be undertaken from the whole and not from a part of a roof.
- Structural deviations were recorded between the concrete elements as well as

those made of structural steelwork, resulting in the 'forcible' placement of the latter, which led to the development of additional stresses, while at the same time reducing the margin of calculated strength.

**Fig. 2.** Global view of the collapsed roof (<http://newcivilengineer.com/archive/engineering-errors-led-to-twente-collapse-stadium-12-07-2012>).

It is obvious that during the construction of such structures the erection plan should exist and rigorously implemented, without modifications, while for possible changes, the stakeholders and the respective construction managers should be informed. At the same time, the control and communication between all parties must be governed by specific procedures and implemented to the letter, even if all the partners work together for many years. Moreover, a suggestion for the designers is to develop highly redundant and robust structural

systems, through continuity of elements and use of bracings. In addition, construction tolerances, even from the initial design, are necessary, because the fabrication and erection are not perfect.

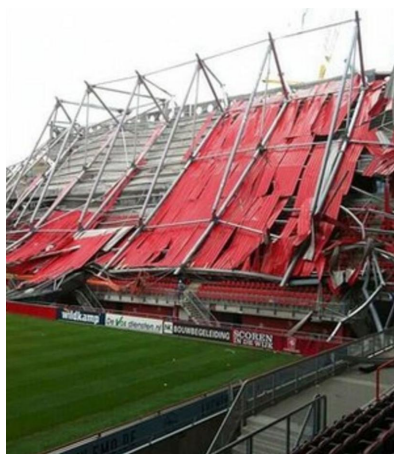
Fig. 3. Local view of the collapsed roof (<http://www.bbc.com/news/world-europe-14063640>).

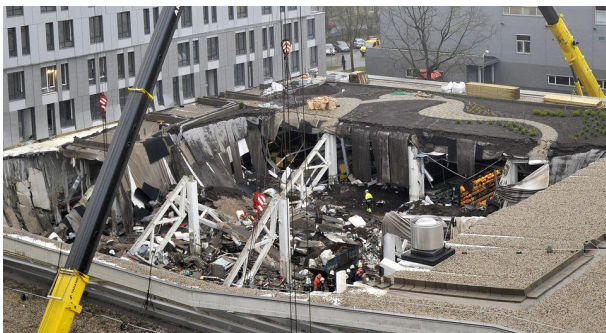
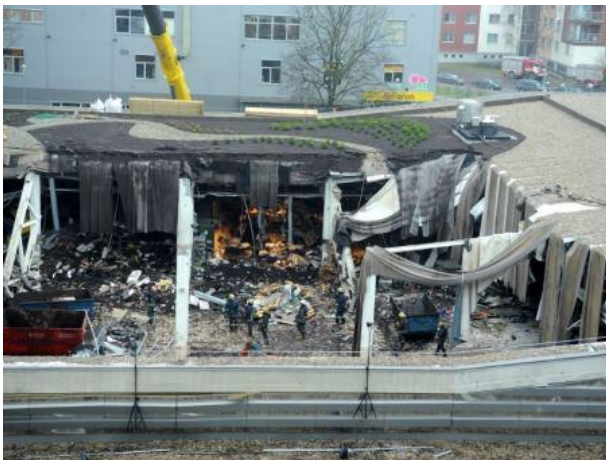
**Fig. 4.** Global view of the Maxima collapsed roof (<http://dailymail.co.uk/news/article-2511652-Latvia-supermarket-roof-collapse-kills-37-Riga.html>).

According to Gusta (2015), the Maxima disaster was due to error in design, errors in construction and inspection process, failure to manage an emergency situation as well as the lowest construction cost, which finally led to the lowest quality of construction. In other words the private profit was over the public safety. This attitude is ethically unacceptable. Certainly, the authorities must

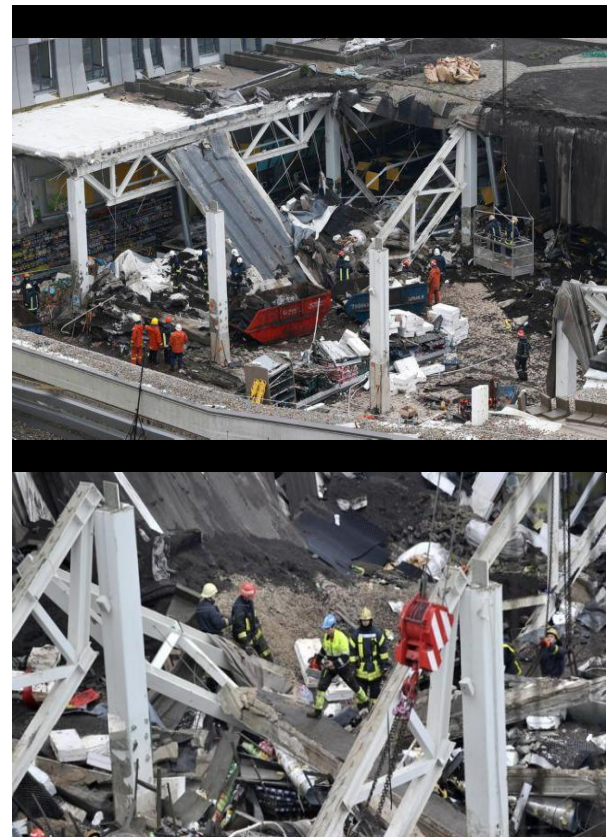
**Fig. 5.** Local view of the Maxima collapsed roof (<https://www.abc.net.au/news/2013-11-22/latvia-supermarket-roof-collapse-kills-dozens/5112572>).

Concerning this failure case, an important technical remark would be made related to the change of a classic roof to a "green roof". For the Maxima supermarket it seems that such loads was not taken into account or not computed correctly (loads in the order of 400-600 kgr/m<sup>2</sup>, due to the fact that previously there was relative rainfall which clearly worsened the load condition of the roof; case of wet soil). Also, the possible unilateral overload led to the failure in combination with the previous ones. This is because the construction of the green roof was in progress, thus changing the intensive situation that probably could not have been foreseen as a distinct construction phase. Therefore, the overload, and the

position of the load during the execution, caused by such a cladding, must be taken into account. Moreover, the improper connection between the trusses (lack of purlins, bracing ties, and a horizontal bracing system), created a system with reduced redundancy, not allowing the formation of a 3D effect of a space structure, which allows force redistribution. For the Maxima supermarket the aforementioned structural solution was not the proper option, possibly for purposes of reducing the construction cost. Therefore, once again it should be pointed out that the redundancy develops alternative load paths, the ductility allows for the force redistribution, and finally, the robustness ensures the integrity of the system. These structural properties save lives and properties as well.

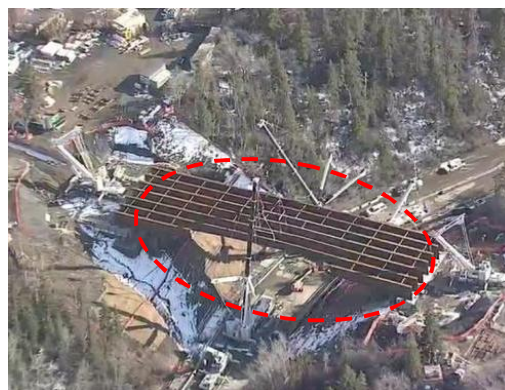
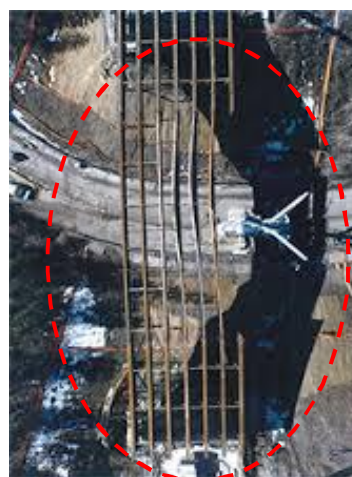
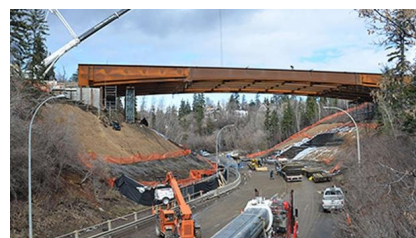
The failure was occurred during the execution phase (at the erection stage), and it is related to four girders of welded double-T cross section with a height of about 4.20m in a bridge with a span of around 100.00m. In Figure 6 the aerial view of the bridge, after failure, is presented (<https://edmonton.ctvnews.ca/damaged-girders-on-102-ave-bridge-repaired-to-be-reinstalled-1.2375088>).

**Fig. 6.** Aerial view of the beams under a failed position (<https://edmonton.ctvnews.ca/damaged-girders-on-102-ave-bridge-repaired-to-be-reinstalled-1.2375088>).

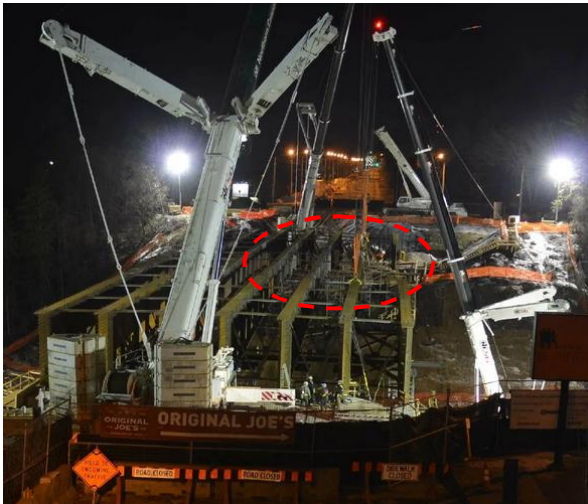
The girders were erected by the steel fabricator on March 15, 2015. Around the first morning time and at 2:00 a.m. (March 16, 2015), as recorded by the web cameras in the project, there was no any

sign of failure (Fig. 7). The beams are still straight.

**Fig. 7.** Beams are straight at 2.00 a.m., on 16 March 2015 (<https://globalnews.ca/news/1887233/groat-road-to-remain-closed-for-three-weeks-for-curved-girder-repairs/>).

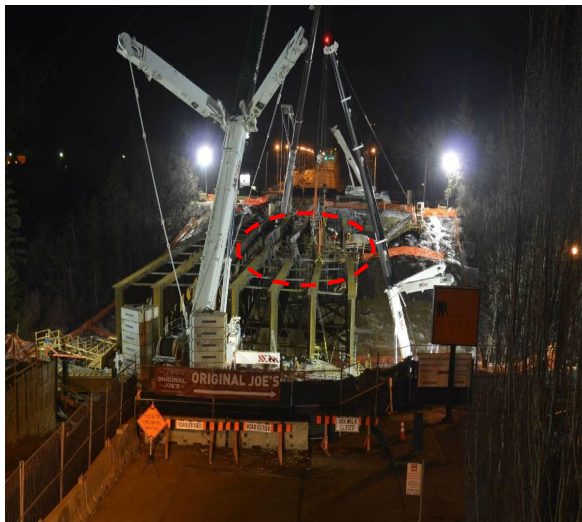
A quarter later at 2:15 a.m. four of the beams are buckled. There were no casualties or injuries but only financial losses (Fig. 8).

**Fig. 8.** Beams failed at 2.15 a.m., on 16 March 2015 (<https://globalnews.ca/news/1887233/groat-road-to-remain-closed-for-three-weeks-for-curved-girder-repairs/>).

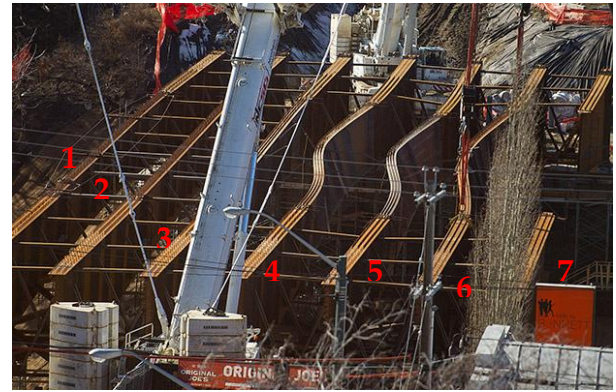
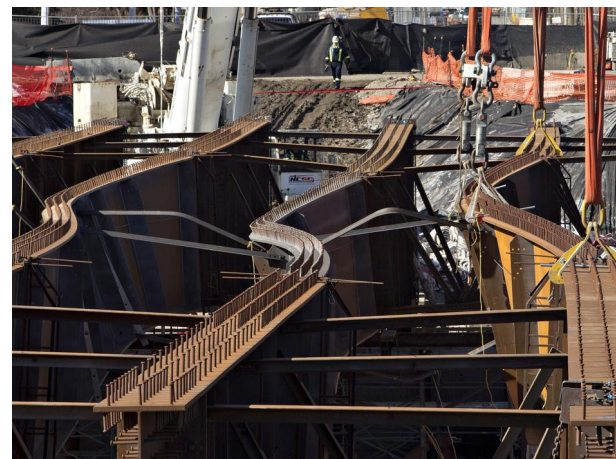
This was a typical failure of flexural torsional buckling, which is a characteristic type of failure for bridge girders of such height and span, when they stay unrestrained (Edmonton Journal, 2015; Zhao *et al.*, 2009) (Fig. 9).

**Fig. 9.** Flexural torsional buckling of the main girders (the 4<sup>th</sup>, 5<sup>th</sup>, 6<sup>th</sup>) (<https://globalnews.ca/news/1887233/groat-road-to-remain-closed-for-three-weeks-for-curved-girder-repairs/>).

- In the failure area in question, e.g. between the 4<sup>th</sup>-5<sup>th</sup>-6<sup>th</sup> beam, the transverse support system (permanent or temporary for construction purposes) was not fully installed after the completion of the construction works on March 15.
- The 6<sup>th</sup> and penultimate beam of the system, out of the total of 7 beams of the bridge, remained incomplete and also unilaterally supported, after the completion of construction works.
- All the of the failed beams show deformations in the same direction. Therefore in the following hours, after the end of the work, due to the incomplete support of the girders the compressed side, probably under the dead weight of

the beam and /or secondary effects that developed after the end of the construction works (e.g. from geometric eccentricities, some type of a gust of wind striking surface of this girder), caused the deflection of the 6<sup>th</sup> and last installed beam which in turn diverted the other two, in a domino-type failure.

- Furthermore, it can be seen that during the construction, the transverse joints were not fully placed on the beams that failed, as respectively they seem to have been placed and exist between the 1<sup>st</sup>-2<sup>nd</sup> and 3<sup>rd</sup> girder. Certainly, the improper placement and connection of the bracing system contributed to the failure, even in the assumption that the study envisaged unilateral beam support, however with the complete installation of the transverse bracing system for the prevention of out-of-plane translational and especially torsional deformations.

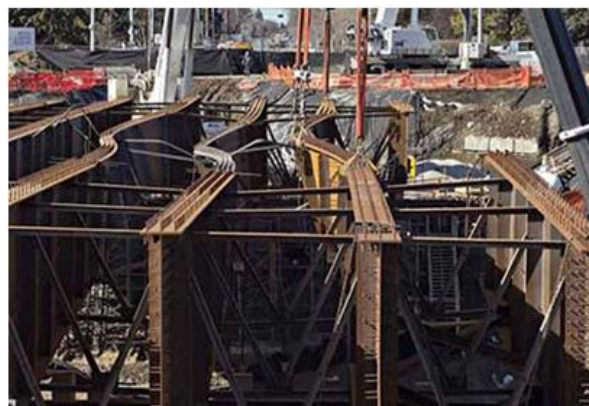
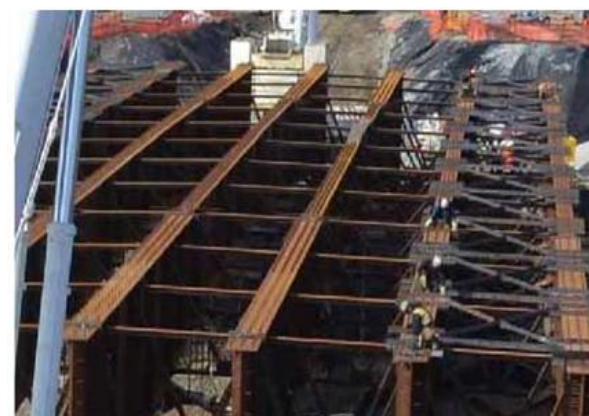
**Fig. 10.** State of the girders before and after repair (<https://www.cbc.ca/news/canada/edmonton/groat-road-bridge-twister-bender-or-bucky-edmontonians-suggest-names-1.3079412>).

In any case, it is very interesting to present the results of the remediation works. It was estimated that the replacement of the girders and the completion of the project would cause a delay of 9 to 12 months. However due to the requirements of the project clauses (approximately \$ 15,000/day) the girders were not replaced but repaired on site, after being dismantled by the bridge under construction, by applying heat straightening methods and cold procedures at the construction site (Fig 10). Such methods are widely applied in bridge construction (Avent and Brakke, 1996; Avent and Mukai, 2001). It is known, of course, that hot straightening, depending on how it was applied in combination of the quality of the steel, alters the mechanical properties of the material and can cause a number of problems, such as accumulation of stresses, reduction of the modulus of elasticity, increase of the yield limit state by about 20%, a relatively smaller increase in tensile

strength, decrease of about one third of ductility, decrease of fatigue limit, decrease of fracture toughness (Avent *et al.*, 2000).

The contractors of the project guaranteed the quality execution of the repair, so at the end they proceeded with the repair despite any initial disagreements and voices to the contrary.
