# LANDSLIDES ANALYSIS USING GEOLOGICAL, GEOTECHNICAL AND GEOPHYSICAL DATA FROM EXPERIMENTAL MEASUREMENTS IN PRAHOVA COUNTY

**Abstract.** The landslide that is the subject of this paper occurred in Prahova County. The present work was carried out to study the spatial influence of geological and morphological factors upon landslide occurrence on a local scale by using geotechnical and geophysical methods in order to determine local trigger parameters. The input data for the slope-stability analysis were collected from topographic investigations, geological mapping. In addition, soil geotechnical parameters were collated from a series of in situ tests. A geophysical survey was applied by using vertical electrical soundings in order to detect the existence and continuity of a potential sliding surface.

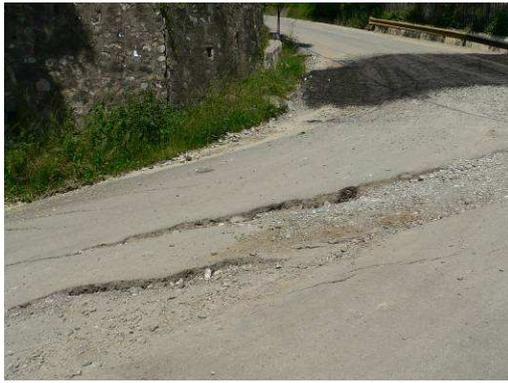
The settlement of county road with 30-40 centimeters on 60 meters portion was mentioned (Fig. 1), with obvious longitudinal and transverse cracks in asphalt pavement because the foundation gave up due to lateral repression of the form strata and

natural ground on which it is located; the road settlement caused damage to houses and traffic restrictions.

**Fig. 1.** The settlement of county road, cracks in the asphalt pavement

- the slope cleaning works (removal of domestic waste deposits) and also edge of the road platform;
- the rehabilitation of the road platform: the slopes and overall dimensions remain existing road platform; the geomorphologic conditions, it is not possible to restoration the slope to the curve;
- at the road platform edge is required to perform a series of drilled micro piles on a row, with specific drilling diameter and inter-axial distance;
- the restoration of the drain situated between the road and the road platform on a considerable distance;
- the removal of the domestic waste deposits from the concrete drain and local repair where the concrete is deteriorated or is missing;

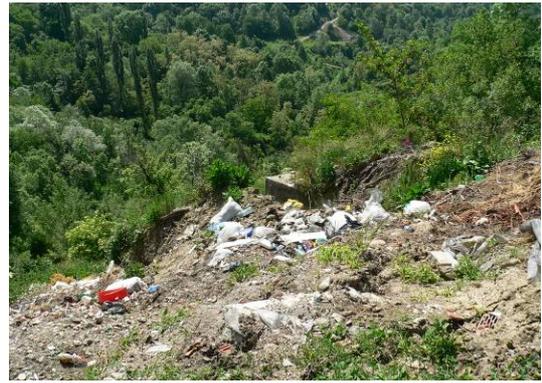
Due to the changing of humidity conditions, the landslide occurred concomitantly with increased erosion to the slope. At the landslide reactivation contribute the loading of the slope because at the top part are stored domestic waste deposits and construction elements (Fig. 2) and caused the growth of shear stresses within a slope.

**Fig. 2.** The loading slope due to household deposits and construction elements

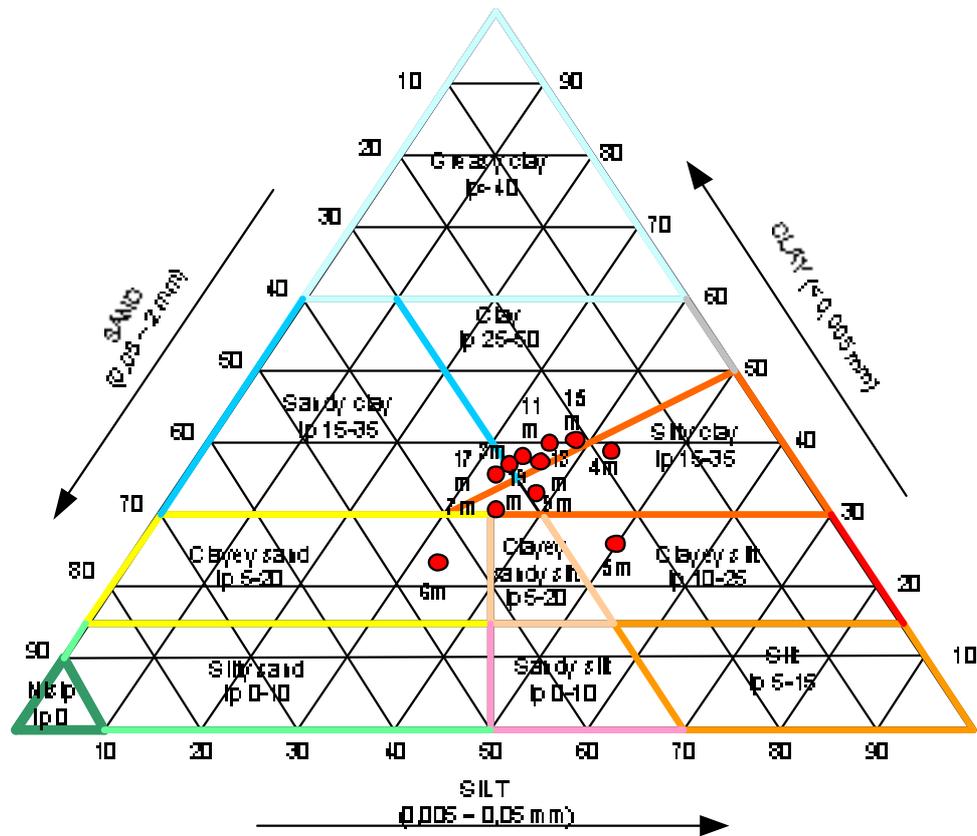
Based on the laboratory tests the following physical soil characteristics were determined: grain size analysis, moisture content, unit weight and density, porosity, pore index, Atterberg limits. Regarding the grain size analysis, the analyzed soil samples are included in the clay soil category, represented by silty clay and sandy clay, as shows in the ternary diagram from Fig. 4.

Fig. 4. The soil classification in the ternary diagram

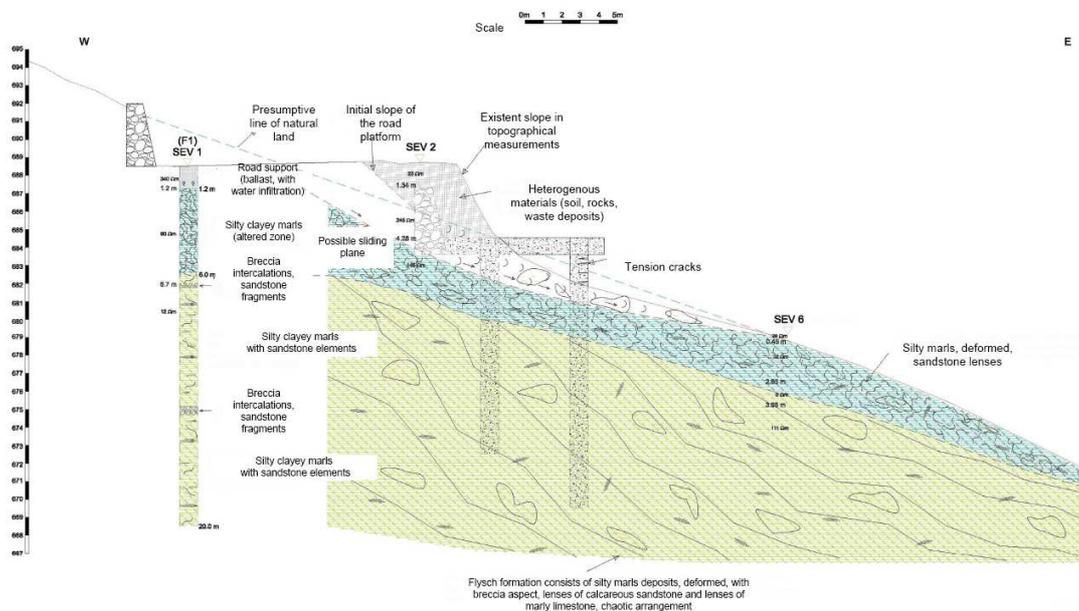
It is mentioned that the sliding surfaces are located up to the contact between layer 2 and 3, and the sliding material can be found in layer 2. On the basis of geoelectrical data, combined with

geological mapping data was prepared a representative geological section for the county road platform (Fig. 5).

Fig. 5. Geological cross section in the county road platform
