PROJECT OF INTERVENTION WORKS TO RESTORE A HISTORICAL COMPLEX - PART I

Abstract. The historical monument called Yellow Ravine (Râpa Galbenă, Rom.) of Iași, subject of a consolidation and rehabilitation, has been in a constant state of decay for several years, up to 2005, when started a project of intervention works to save the complex.

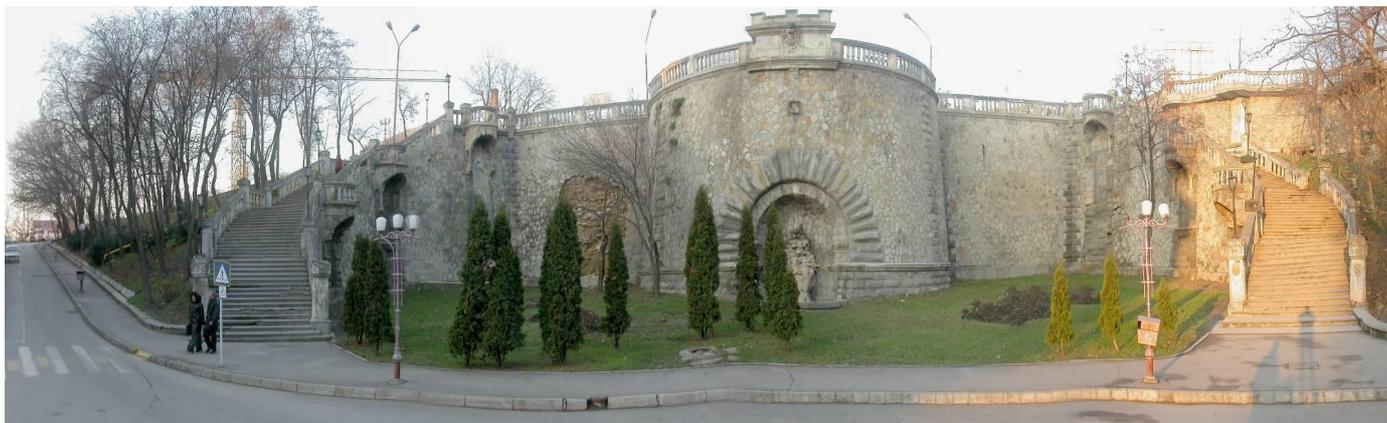
a constant state of decay for several years. A basic visual analysis (Fig. 1, 2, 3, and 5) revealed the damage of the supporting wall, stairs, parapet walls and balusters and a slow landslide of the right slope. The damaged area was of 5200 m². Taking into account the historical, architectural and practical utility of the monument, its consolidation and rehabilitation was immediately required. Any delay would have caused the monument's condition to grow worse and further rehabilitation costs would have been incurred.

Fig. 1. – Front view photo of the historical monument Yellow Ravine Complex
Location: Central area of Iasi municipality between G. Muzicescu, Railway Station,
Yellow Ravine and Gh. Lazăr Streets, covers nearly 7000 m².

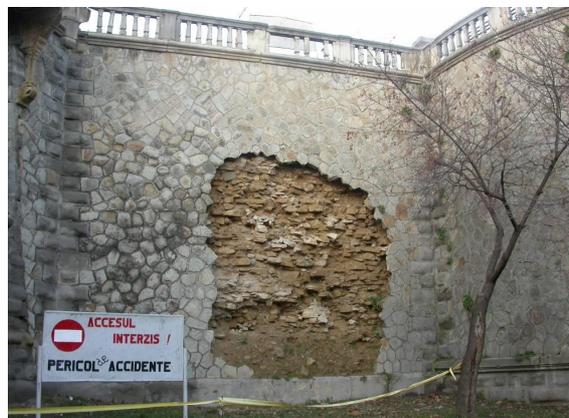
Fig. 2. Detail of the deterioration of the finish layer and of the damaged supporting wall, stairs, parapet walls and balusters

- restore the damaged elements: stairs, parapet walls, balusters, balconies...made of stone resembling the material initially used; cleaning the salt deposits from the front's coverage;
- redesigning the sewage of the monument in order to remove the possibility of water leakage and infiltration in the supporting wall, or the landslide from the 1st and 3rd areas;
- remodeling ditches and gutters to take in surface waters;
- growing grass on the entire area or laying a garden lawn, especially on the slopes of the 1st and 3rd areas.

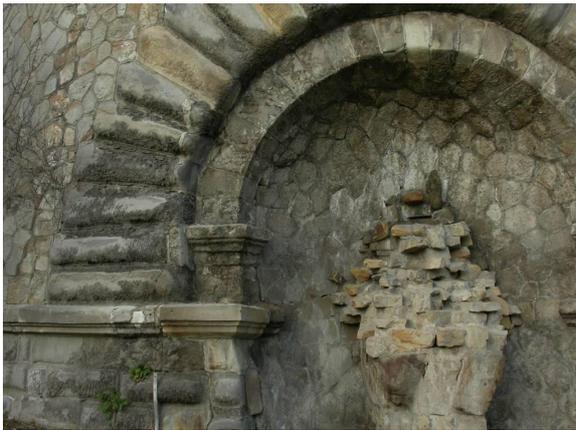
Fig. 3. Detail of the deterioration of the finish layer and of the damaged supporting wall, stairs, parapet walls and balusters

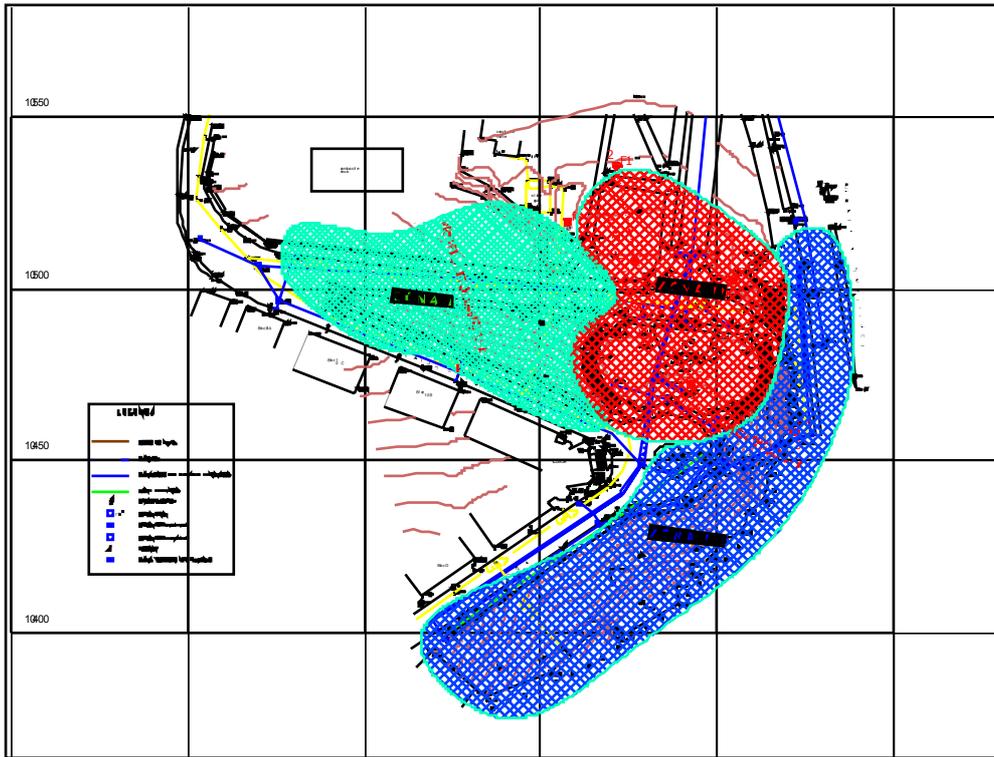
The main cause of these deteriorations was the water coming from the groundwater layer and from the urban sewage system leaks, as well as from rain. This finding is also supported by the fact that the damaged area was located exactly near a rain water drain which gets easily clogged up by large flows (diagrams P1 and P2).

Diagram P1 – dividing the location into three distinct areas (taking the roundabout as reference point) where drillings F1...F6 were performed in 1st, 2nd, 3^d Areas.

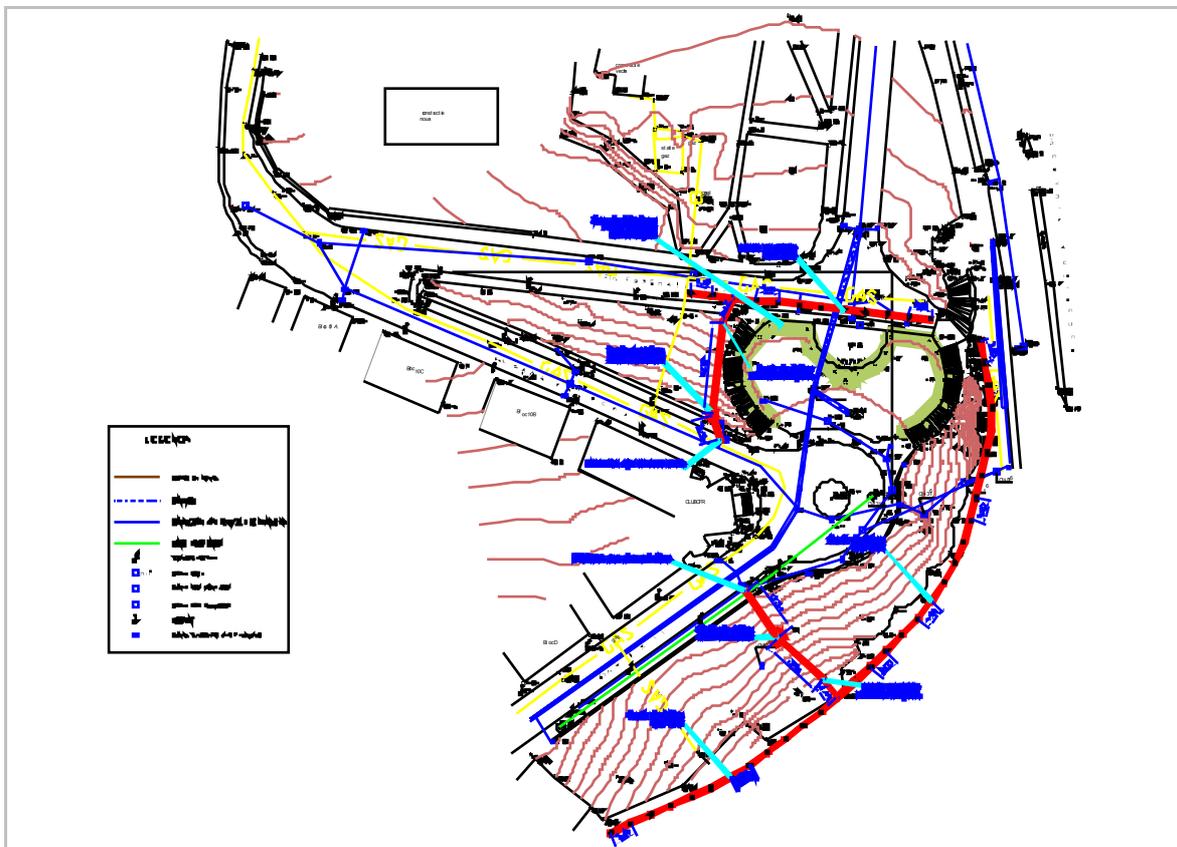
Diagram P2 – Action plan – the three drain networks placed in locations to increase their efficiency

During the examination of this part of the monument, an underground shaft was found (displayed in Diagram P2) through which sewage water and the water drained from the upstream are flowing towards The Railway Street. The construction is well preserved except for the wall of an internal refuge, whose brickwork is displaced.

of the stability to landslide calculation, in order to strengthen the historical complex Yellow Ravine and to restore its initial appearance, the project solution after the feasibility study, considered to *lower the groundwater level to 9.00 ÷ 9.50 m compared to CTA, to create proper conditions for the monument's brickwork drying*. Thus, it was removed the main cause of deterioration of the supporting wall coverage and of the left slope (Fig. 1 and diagrams P1, P2) As there was a difference of level between G. Lazăr and Railway Station Streets of nearly 10 m (86, respectively 76 m height above sea level) it was necessary to lower the groundwater level with practically the same value. The water will flow into the shaft with automatic lock chambers, built at the height of +78.85 m above sea level and from here it will be discharged in the urban sewage system located along the Yellow Ravine Street.

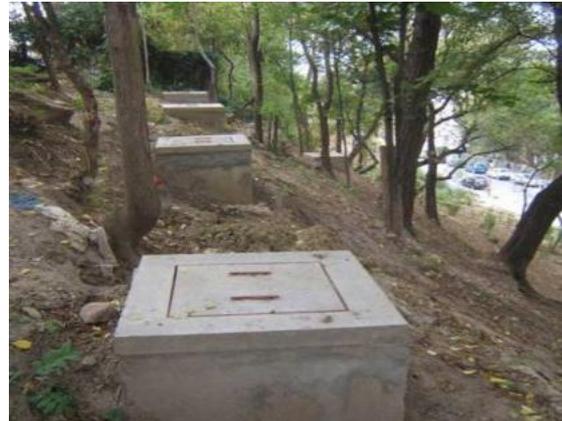
Fig. 4. - Overview of shafts

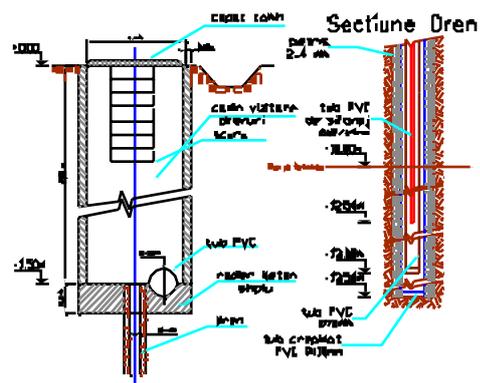
Fig. 5. - Detail of a drain section

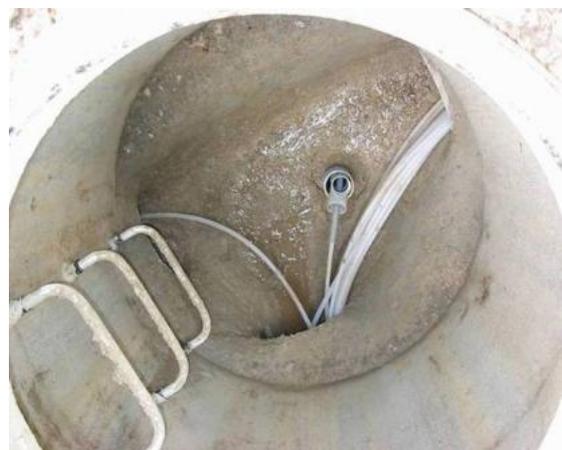
Fig. 6. Gravitational drain shaft

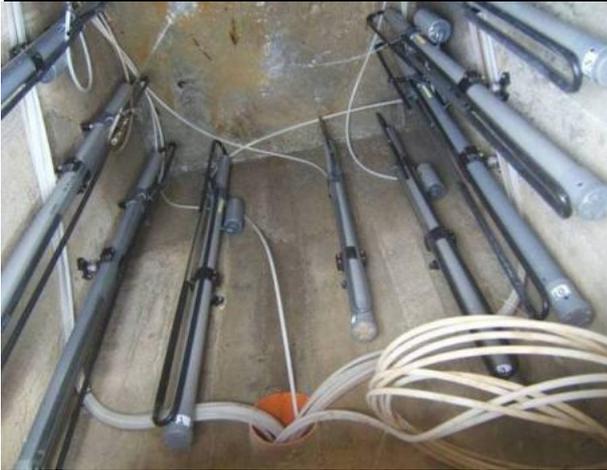
Fig. 7. - Automated lock shaft

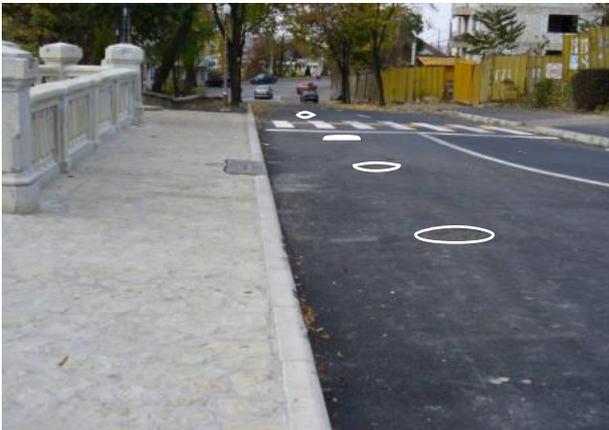
Fig. 8. - View after end of works

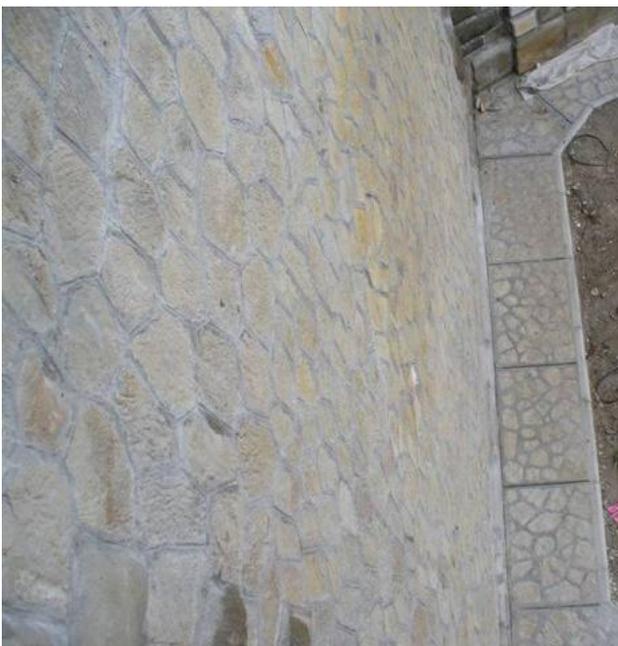
Fig. 9. - The dry wall after drainage works
