# FIELD SURVEY AND LABORATORY TESTS ON COMPOSITE MATERIALS CASE OF GRP (GLASS FIBER REINFORCED POLYESTER) TUBES FOR WATER SUPPLY

**Abstract.** In the Moldova land, were made two lines of water adduction, having 6000 m length and 40 m slope, or 1/150 slope. The water supply component tubes were disposed under the plant: The tubes are made of glass - reinforced thermosetting plastics (GRP). After about 180 days of operation, one of the lines showed severe deterioration of the quality pipe components.

This paper deals with some laboratory tests in order to detect the failure cases of the pipelines components.

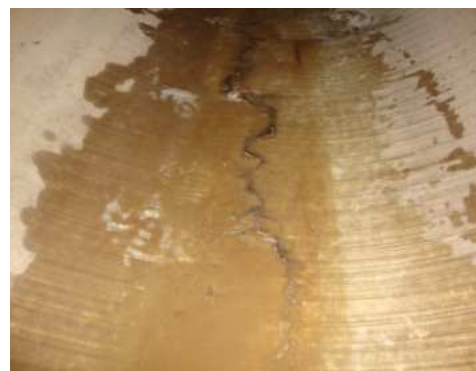
**Fig. 1.** Longitudinal crack in pipes

After about six month of operation, one of the lines showed severe deterioration, as shown in Fig. 1 ... Fig. 4.

c) The destruction of the pipe wall is not caused by the poor quality of the material but due to a serious non-conforming aspects, technological point of view, occurred during the manufacturing process.

d) Severe damages shown in Fig. 1 ... Fig. 4 can be explained by the emergence of some accidental forces of high intensity. The mechanism of such forces may be due to an unexpected water hammer.

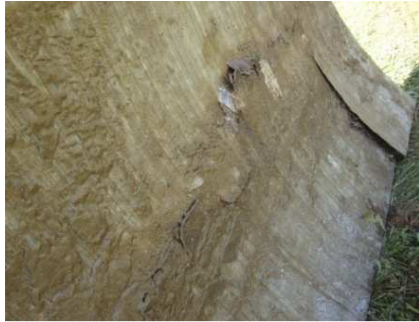
Fig. 2. Longitudinal crack in pipes

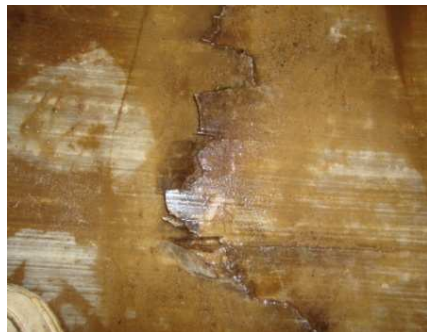
Fig. 3. Longitudinal crack in pipes

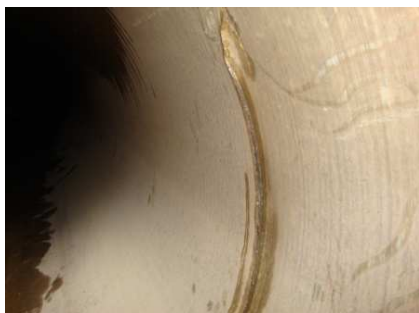
Fig. 4. Circumferential crack in pipes

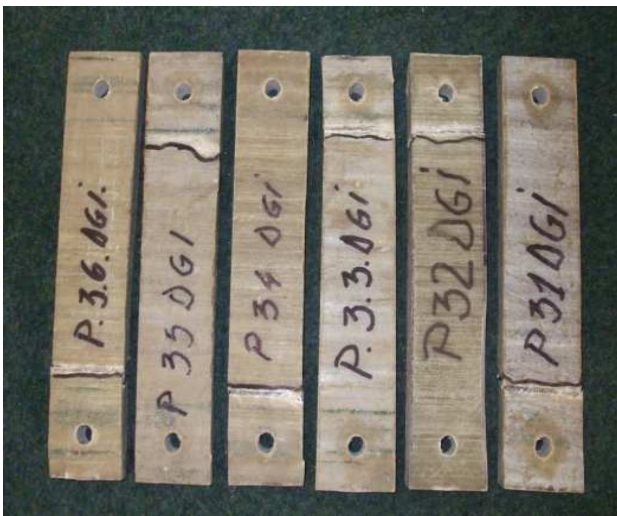
Prismatic test specimens consist of segments with dimensions  $l * b * h = 250 * 50 * 20$  mm, cut from the tube type III (DGI 106) DN 1300 mm nominal diameter and nominal pressure PN 6.

The size specimens tested on initial longitudinal tensile is presented in the results table (Table 1). Allure of the test specimens is shown in Fig. 5.

Fig. 5. Test specimens type III (DGI 106)

a) Apparent initial tensile resistances both in the longitudinal and the circular direction, is much higher than the minimum reference values. This confirms the quality of the material put into practice.

b) Studying the breaking of the pipe rings shown in the attached photos, it has been found that the cracks occurs mainly in the pipe wall core, in the middle section, when the maximum normalized deflection ring is achieved.

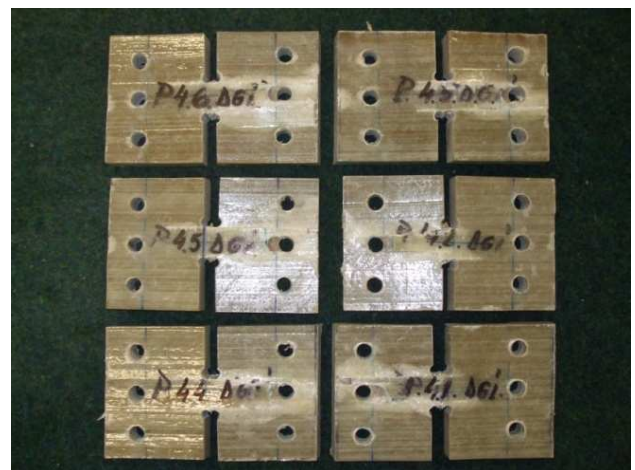
a) Description of the test pieces:  
The prismatic test specimens consist of segments with dimensions  $l * b * h = 250 * 50 * 20$  mm, cut from the tube type III (DGI 106) DN 1300 mm nominal diameter and nominal pressure PN 6. The size test pieces was as specified in (SR EN 1393, 2003), page 7, section 5.2, section 5.2.1 (b) Section 5.2.2.3, page 8-9, Method A.

The size specimens, tested on apparent initial circumferential tensile, is presented in the results table (Table 2). Allure of the test specimens is shown in Fig. 6.

Fig. 6. Test specimens type III (DGI)
